**REMOVAL AND REPAIR OF
EBR-II PRIMARY SODIUM PUMP NO. 1**

**B. C. Cerutti, G. E. Deegan, J. D. Nulton,
W. H. Perry, and R. E. Seever**

EBR-II Project

May 1972

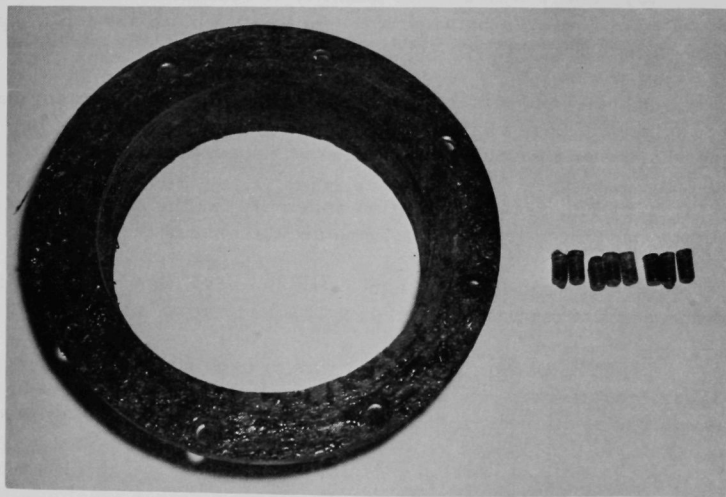
Fig. 9. Removed Lower Labyrinth. ANL Neg. No. 103-O5364.

An attempt was made to remove the badly corroded lower-labyrinth assembly bolts; however, they could not be removed by wrench. Owing to the limited access, an air-operated angle drill was used to try to drill out the bolts (1/2-in. socket head). The drilling was proceeding very slowly (5 min would dull the drill bits) when it was noted that the hard sodium oxide buildup on the pump shaft above the seal had softened because of moisture absorption from the air. The bolt drilling was stopped, the pump shaft was scraped free of sodium oxide, and the baffle removal proceeded with the lower labyrinth installed.

(3) Considerable corrosion of the lower labyrinth had destroyed its usefulness (see Fig. 9).

The internal serrations of the lower labyrinth were modified to improve the argon flow down between the seal and the pump shaft. The modification changed the eight-pitch, right-hand, single-lead helix to an eight-pitch, left-hand, four-lead helix. This will aid the argon flow down the pump shaft and oppose the "climbing" of sodium and sodium oxide up the counterclockwise-rotating pump shaft (see Fig. 20).

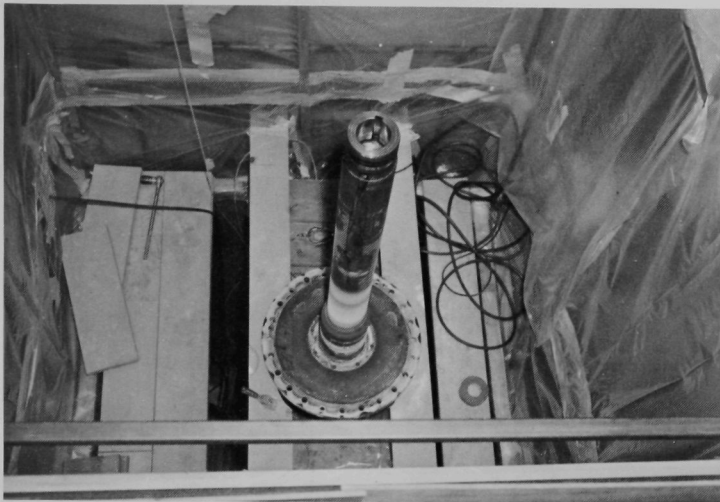
Fig. 10. Sodium Oxide on Pump Shaft. ANL Neg. No. 103-O5099.

The length of pump shaft exposed by the shield/plug removal was examined. The rub marks on the shaft, the sodium oxide buildup, the corroded condition of the lower labyrinth, and the grease-trail patterns on the shaft were noted.

(6) Grease from the lower bearing of the drive motor had leaked into the end bore of the pump shaft, out the keyway relief holes, and down the shaft (see Fig. 10).

The two keyway-relief holes were plugged (see Fig. 19) to prevent grease leakage from the pump-shaft bore, in case there is any future leakage past the grease retainer. There is a tapped hole at the bottom of the shaft bore for the drawbolt. This hole, plus the void space in the bore, provide ample reservoir capacity to hold the small amount of grease that might leak past the retainer.

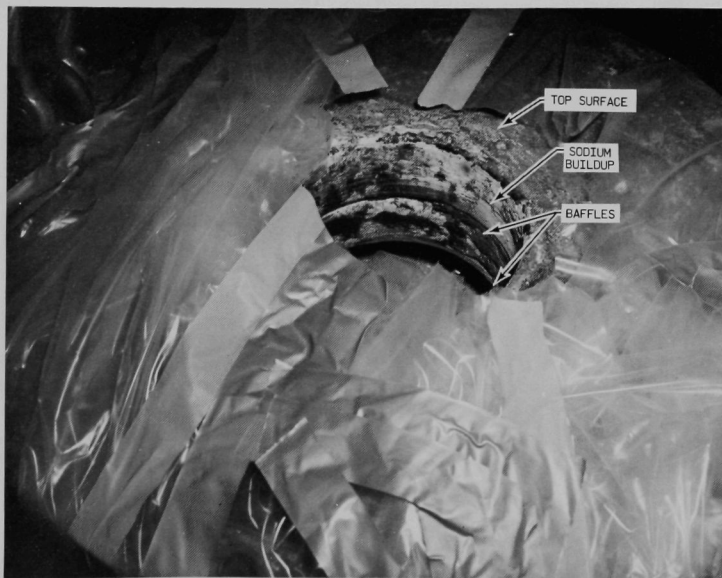
Fig. 11. Sodium Oxide in Baffle. ANL Neg. No. 103-O5194A.

The argon supply inside the enclosure was used to slow the sodium-air reactions during disassembly. Occasionally the sodium adhering to a pump surface started to "bubble." When this happened, the technicians wrapped the area with an asbestos blanket and inserted the argon-supply Tygon tube under the blanket with the flow set at 5-10 cfh. This slowed the reaction until the sodium was safely oxidized. This system proved very efficient. It was used once to extinguish a small fire that started within the baffle subassembly. The fire was extinguished within a few seconds, even though there was approximately 75 lb of sodium and sodium oxide inside the baffle.

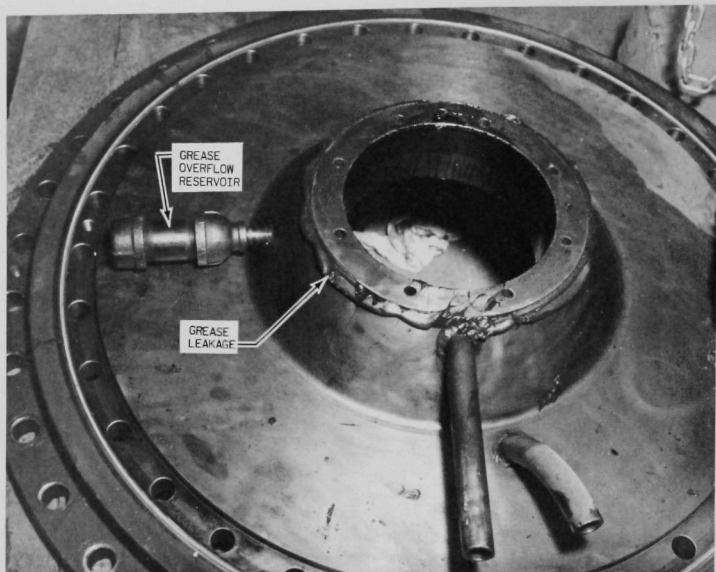
Fig. 12. Seal for Lower Bearing of Drive Motor. ANL Neg. No. 103-O5063A.

(7) The grease-retention assembly for the lower bearing of the drive motor had failed to completely retain the grease (see Fig. 12).

The only problem revealed by the drive-motor inspection was failure of the lower-bearing grease-retention system to retain all the grease.

The excess grease did not go into the small reservoir provided in the lower motor-support flange. This caused some grease to leak out and down the pump shaft. The reservoir was removed, permitting the entire space above the support flange to become a reservoir. Reliefs were machined in the assembly plate to provide easier overflow to the enlarger reservoir (see Fig. 18).

The grease-application period was changed from once every 900 hr to once every 1800 hr. The type of grease was changed on this pump only, for trial use. This modification plus the new felt seal should eliminate the grease leakage.

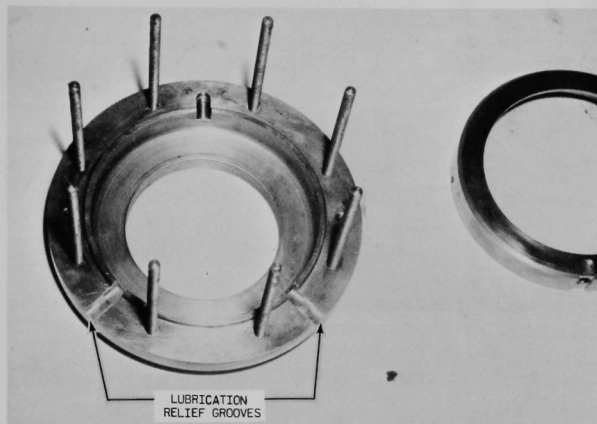
Fig. 18. Modified Grease Retainer for Lower Bearing of Drive Motor. ANL Neg. No. 103-O5603A.

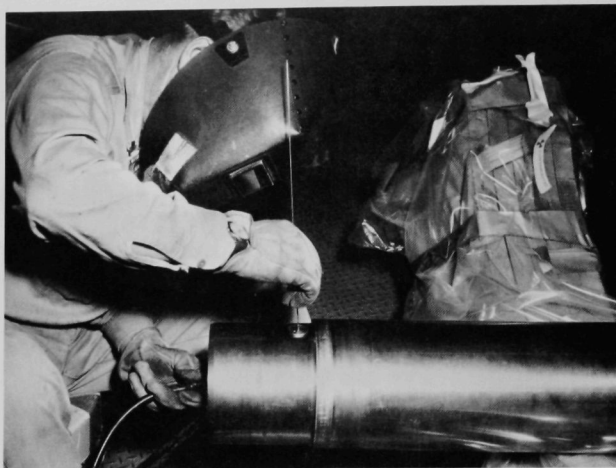
Fig. 19. Plugging of Keyway Relief Holes on Pump Shaft. ANL Neg. No. 103-O5523.

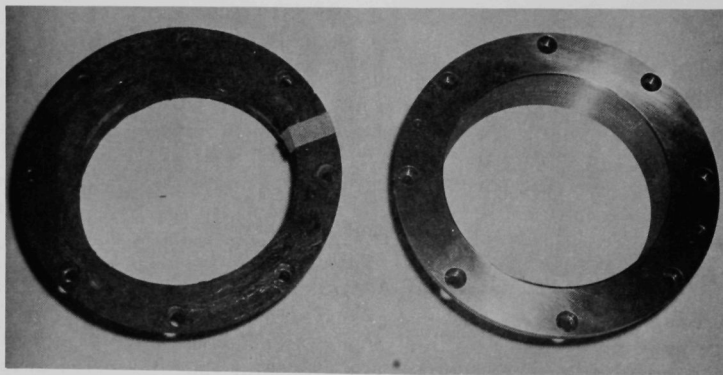
Fig. 20. New Modified Lower Labyrinth (right). ANL Neg. No. 103-O5480.

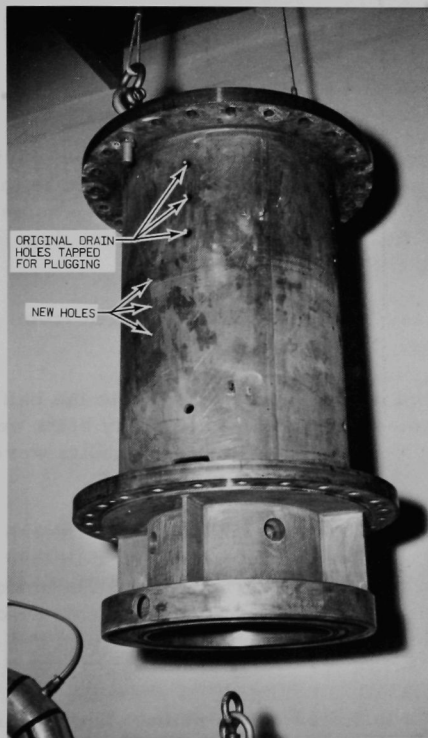
Fig. 21. Modified Baffle, with Arrows Showing New Drain Holes for Argon Purge Flow. ANL Neg. No. 103-O5557A.

The purpose of the baffle plates, drain holes, and slinger grooves was to keep sodium from climbing the rotating pump shaft by being thrown off and then draining back to the bulk sodium. The examination of pump No. 1 demonstrated that this system failed to function as planned. Sodium oxide filled the slinger grooves, plugged the baffle drain holes, filled the spaces between baffle plates with sodium oxide, filled the lower-labyrinth seal-serration grooves and shaft clearance, and built up above the lower labyrinth seal.
